# **PIERCE ELEMENTARY SCHOOL**

## Outlet Sampling and Plumbing Assessment Recommendations

1101 West Vernon Drive, Flint, Michigan 48503

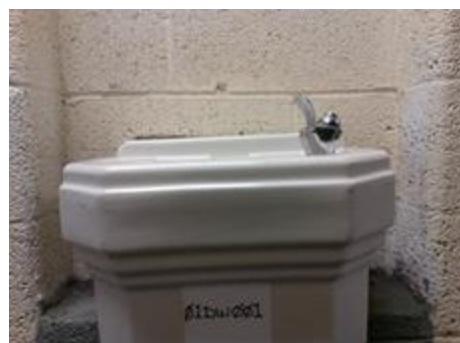
### **Outlet:     Bubbler Drinking Fountain (01DW001)**

Location:   Hallway next to Boiler Room, behind Stage

Results:     P1=20 parts per billion, P2=2 parts per billion  
                F01=2 parts per billion, F02=non-detect

These results suggest the highest contribution of lead may be from the bubbler itself. This bubbler fixture is made of chrome-plated brass. Connecting plumbing should be checked for brass components, including brass valves.

Replacement of this bubbler tap and its connecting plumbing with lead-free materials will significantly reduce lead exposure at this location. If replacement is not currently feasible, sample results indicate that flushing this tap for three minutes following periods of stagnation is likely to reduce lead concentrations and lead exposure.

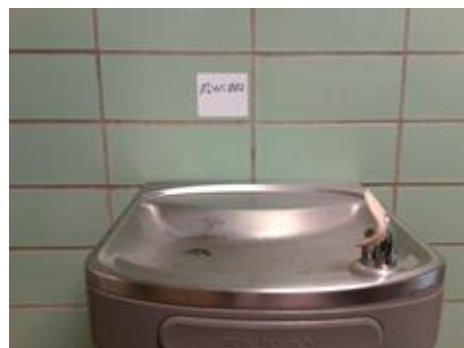
### **Outlet:     Water Cooler Fountain (01WC002)**

Location:   Hallway next to Mechanical Room, north corridor

Results:     P1=8 parts per billion, P2=13 parts per billion  
                F01=35 parts per billion, F02=19 parts per billion

These results suggest the lead may be from the water cooler unit and the connecting plumbing. The water cooler is an Elkay model. This model may contain brass components. Connecting plumbing to the cooler unit may also contain brass components.

Replacement of this water cooler and its connecting plumbing with lead-free materials will significantly reduce lead exposure at this location and needs to be completed for use. If replacement is not currently feasible, **SHUT OFF THIS WATER COOLER FOUNTAIN AND DO NOT USE THIS WATER COOLER FOR DRINKING OR COOKING.**

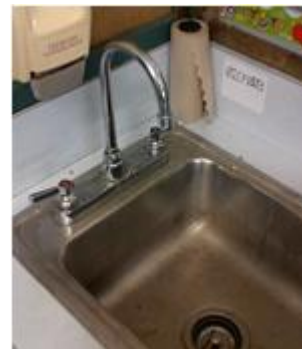
**Outlet: Sink Faucet (01CF003)**

Location: Classroom 109, northeast wall

Results: P1=26 parts per billion, P2=17 parts per billion  
F01=9 part per billion, F02=2 parts per billion

These results suggest the highest contribution of lead may be from the faucet and its connecting plumbing. This model faucet typically has a brass tube in its deck body, and may contain some additional brass components. Connecting plumbing in the cabinet under the sink should be checked for brass components, including brass valves.

Replacement of this faucet and its connecting plumbing with lead-free materials will significantly reduce lead exposure at this location. If replacement is not currently feasible, sample results indicate that flushing this tap for three minutes following periods of stagnation is likely to reduce lead concentrations and lead exposure.

This faucet also has an aerator/screen at the outlet. If the faucet is not replaced, the aerator/screen should be removed, inspected for particulate accumulations, scrubbed clean, and reinstalled. If particulates are found, the aerator/screen should be periodically checked and cleaned.

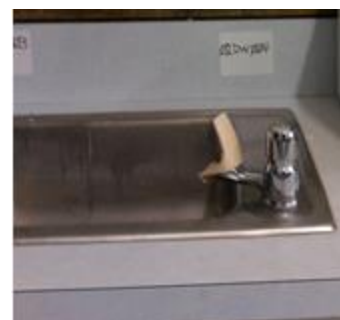
**Outlet: Bubbler Fountain (01DW004)**

Location: Classroom 109, northwest wall

Results: P1=42 parts per billion, P2=17 parts per billion  
F01=3 parts per billion, F02=1 part per billion

These results suggest the highest contribution of lead may be from the bubbler and its connecting plumbing. This bubbler fixture is made of chrome-plated brass and has a brass connector on the underside of the sink. Connecting plumbing in the cabinet under the sink should be checked for brass connectors, copper piping with lead solder, and a brass shut-off valve.

Replacement of this bubbler tap and its connecting plumbing with lead-free materials will significantly reduce lead exposure at this location. If replacement is not currently feasible, sample results indicate that flushing this tap for three minutes following periods of stagnation is likely to reduce lead concentrations and lead exposure.

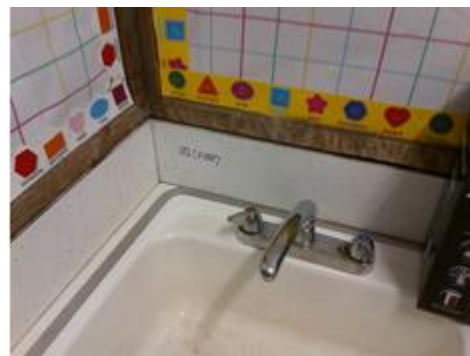
**Outlet: Sink Faucet (01CF007)**

Location: Classroom 108, northwest wall

Results: P1=97 parts per billion, P2=132 parts per billion  
F01=9 parts per billion, F02=2 parts per billion

These results suggest the highest contribution of lead may be from the faucet and its connecting plumbing. This faucet appears to be manufactured by Central Brass. This model faucet typically has a brass tube in its deck body, may contain some additional brass components, and has a brass spout. Connecting plumbing in the cabinet under the sink should be checked for brass connectors, copper piping with lead solder, and brass shut-off valves.

Replacement of this faucet and its connecting plumbing with lead-free materials will significantly reduce lead exposure at this location. If replacement is not currently feasible, sample results indicate that flushing this tap for three minutes following periods of stagnation is likely to reduce lead concentrations and lead exposure.

This faucet also has an aerator/screen at the outlet. If the faucet is not replaced, the aerator/screen should be removed, inspected for particulate accumulations, scrubbed clean, and reinstalled. If particulates are found, the aerator/screen should be periodically checked and cleaned.

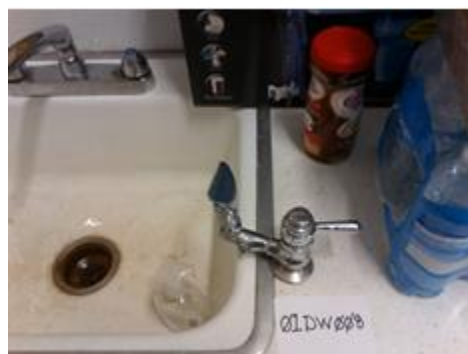
**Outlet: Bubbler Fountain (01DW008)**

Location: Classroom 108, northwest wall

Results: P1=468 parts per billion, P2=75 parts per billion  
F01=6 parts per billion, F02=4 parts per billion

These results suggest the highest contribution of lead may be from the bubbler and its connecting plumbing. This bubbler fixture is made of chrome-plated brass, with a brass operating valve, and a brass connector on the underside of the sink. Connecting plumbing under the sink should be checked for brass components and copper piping with lead solder.

Replacement of this bubbler tap and its connecting plumbing with lead-free materials will significantly reduce lead exposure at this location. If replacement is not currently feasible, sample results indicate that flushing this tap for three minutes following periods of stagnation is likely to reduce lead concentrations and lead exposure.

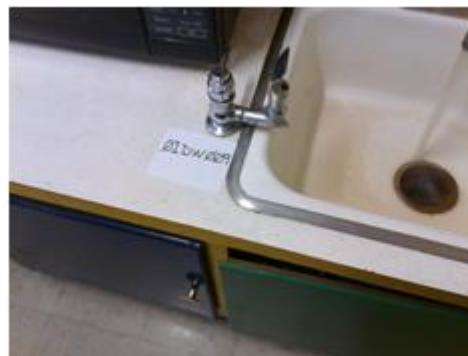
### **Outlet: Bubbler Fountain (01DW009)**

Location: Classroom 111, northeast wall

Results: P1=26 parts per billion, P2=38 parts per billion  
F01=7 parts per billion, F02=3 parts per billion

These results suggest the highest contribution of lead may be from the bubbler and its connecting plumbing. This bubbler fixture is made of chrome-plated brass, with a brass operating valve, and a brass connector on the underside of the sink. Connecting plumbing in the cabinet under the sink should be checked for brass components and copper piping with lead solder.

Replacement of this bubbler tap and its connecting plumbing with lead-free materials will significantly reduce lead exposure at this location. If replacement is not currently feasible, sample results indicate that flushing this tap for three minutes following periods of stagnation is likely to reduce lead concentrations and lead exposure.

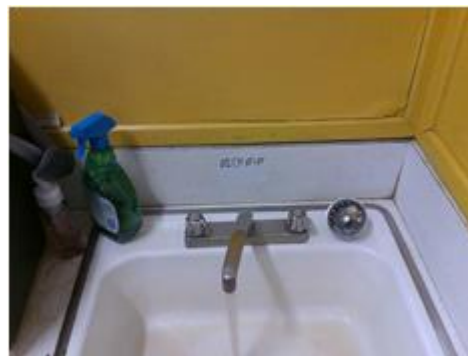
### **Outlet: Sink Faucet (01CF010)**

Location: Classroom 111, northeast wall

Results: P1=43 parts per billion, P2=22 parts per billion  
F01=3 parts per billion, F02=3 parts per billion

These results suggest the highest contribution of lead may be from the faucet and its connecting plumbing. This faucet appears to be manufactured by Central Brass. This model faucet typically has a brass tube in its deck body, may contain some additional brass components, and has a brass spout. The spout's chrome finish is worn down to the brass. Connecting plumbing in the cabinet under the sink should be checked for brass connectors, copper piping with lead solder, and brass shut-off valves.

Replacement of this faucet and its connecting plumbing with lead-free materials will significantly reduce lead exposure at this location. If replacement is not currently feasible, sample results indicate that flushing this tap for three minutes following periods of stagnation is likely to reduce lead concentrations and lead exposure.

This faucet also has an aerator/screen at the outlet. If the faucet is not replaced, the aerator/screen should be removed, inspected for particulate accumulations, scrubbed clean, and reinstalled. If particulates are found, the aerator/screen should be periodically checked and cleaned.

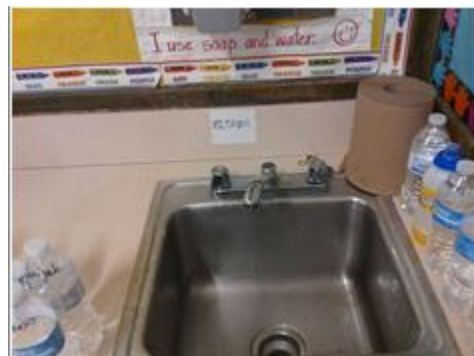
### **Outlet: Sink Faucet (01CF011)**

Location: Classroom 107, southwest wall

Results: P1=25 parts per billion, P2=11 parts per billion  
F01=3 parts per billion, F02=2 parts per billion

These results suggest the highest contribution of lead may be from the faucet and its connecting plumbing. This faucet appears to be manufactured by Central Brass. This model faucet typically has a brass tube in its deck body, may contain some additional brass components, and has a brass spout. Connecting plumbing in the cabinet under the sink should be checked for brass connectors, copper piping with lead solder, and brass shut-off valves.

Replacement of this sink faucet and its connecting plumbing with lead-free materials will significantly reduce lead exposure at this location. If replacement is not currently feasible, sample results indicate that flushing this tap for three minutes following periods of stagnation is likely to reduce lead concentrations and lead exposure.

At the time of assessment, the faucet aerator/screen was found removed. If the faucet is not replaced and the aerator/screen is going to be reinstalled, it should be inspected for particulate accumulations, and scrubbed clean. If particulates are found, the aerator/screen should be periodically checked and cleaned.

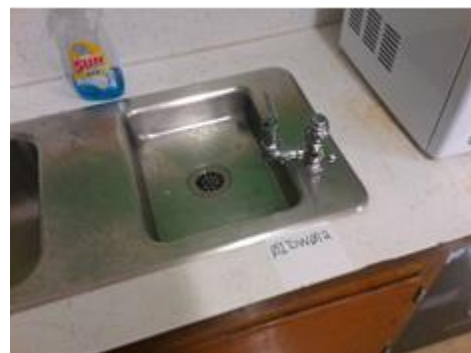
### **Outlet: Bubbler Fountain (01DW012)**

Location: Classroom 112, southwest wall

Results: P1=78 parts per billion, P2=11 parts per billion  
F01=4 parts per billion, F02=3 parts per billion

These results suggest the highest contribution of lead may be from the bubbler and its connecting plumbing. This bubbler fixture is made of chrome-plated brass, with a brass operating valve and a brass connector on the underside of the sink. Connecting plumbing under the sink should be checked for brass components and copper piping with lead solder.

Replacement of this bubbler tap and its connecting plumbing with lead-free materials will significantly reduce lead exposure at this location. If replacement is not currently feasible, sample results indicate that flushing this tap for three minutes following periods of stagnation is likely to reduce lead concentrations and lead exposure.

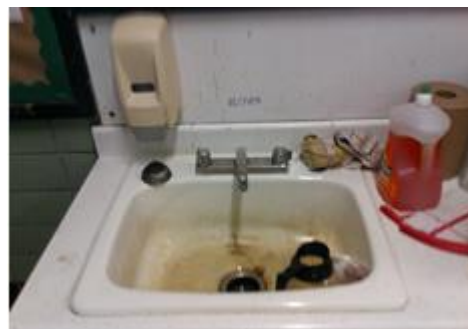
### **Outlet: Sink Faucet (01CF018)**

Location: Classroom 301, northwest wall

Results: P1=13 parts per billion, P2=16 parts per billion  
F01=4 parts per billion, F02=1 part per billion

These results suggest the highest contribution of lead may be from the faucet and its connecting plumbing. This faucet appears to be manufactured by Central Brass. This model faucet typically has a brass tube in its deck body, may contain some additional brass components, and has a brass spout. The spout's chrome finish is worn down to the brass. Connecting plumbing in the cabinet under the sink should be checked for brass connectors, copper piping with lead solder, and brass shut-off valves.

Replacement of this faucet and its connecting plumbing with lead-free materials will significantly reduce lead exposure at this location. If replacement is not currently feasible, sample results indicate that flushing this tap for three minutes following periods of stagnation is likely to reduce lead concentrations and lead exposure.

This faucet also appears to have an aerator/screen at the outlet. If the faucet is not replaced, the aerator/screen should be removed, inspected for particulate accumulations, scrubbed clean, and reinstalled. If particulates are found, the aerator/screen should be periodically checked and cleaned.

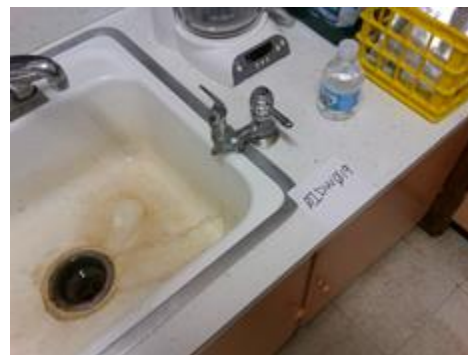
### **Outlet: Bubbler Fountain (01DW019)**

Location: Classroom 302, southwest wall

Results: P1=220 parts per billion, P2=23 parts per billion  
F01=3 parts per billion, F02=2 parts per billion

These results suggest the highest contribution of lead may be from the bubbler and its connecting plumbing. This bubbler fixture is made of chrome-plated brass, with a brass operating valve, and a brass connector on the underside of the sink. Connecting plumbing in the cabinet under the sink should be checked for brass components and copper piping with lead solder.

Replacement of this bubbler tap and its connecting plumbing with lead-free materials will significantly reduce lead exposure at this location. If replacement is not currently feasible, sample results indicate that flushing this tap for three minutes following periods of stagnation is likely to reduce lead concentrations and lead exposure.

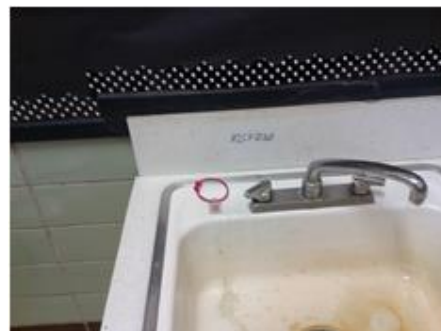
**Outlet: Sink Faucet (01CF020)**

Location: Classroom 302, southwest wall

Results: P1=53 parts per billion, P2=30 parts per billion  
F01=1 part per billion, F02=non-detect

These results suggest the highest contribution of lead may be from the faucet and its connecting plumbing. This faucet appears to be manufactured by Central Brass. The base of this faucet is chrome-plated brass, has brass components within the base, and a brass spout. The spout's chrome finish is worn down to the brass. Connecting plumbing in the cabinet under the sink should be checked for brass connectors, copper piping with lead solder, and brass shut-off valves.

Replacement of this faucet and its connecting plumbing with lead-free materials will significantly reduce lead exposure at this location. If replacement is not currently feasible, sample results indicate that flushing this tap for three minutes following periods of stagnation is likely to reduce lead concentrations and lead exposure.

This faucet also appears to have an aerator/screen at the outlet. If the faucet is not replaced, the aerator/screen should be removed, inspected for particulate accumulations, scrubbed clean, and reinstalled. If particulates are found, the aerator/screen should be periodically checked and cleaned.

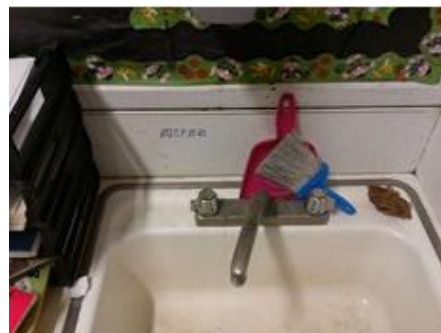
**Outlet: Sink Faucet (01CF021)**

Location: Classroom 306, southwest wall

Results: P1=15 parts per billion, P2=50 parts per billion  
F01=8 parts per billion, F02=3 parts per billion

These results suggest the highest contribution of lead may be from the faucet and its connecting plumbing. This faucet appears to be manufactured by Central Brass. This model faucet typically has a brass tube in its deck body, may contain some additional brass components, and has a brass spout. The spout's chrome finish is worn down to the brass. Connecting plumbing in the cabinet under the sink should be checked for brass connectors, copper piping with lead solder, and brass shut-off valves.

Replacement of this faucet and its connecting plumbing with lead-free materials will significantly reduce lead exposure at this location. If replacement is not currently feasible, sample results indicate that flushing this tap for three minutes following periods of stagnation is likely to reduce lead concentrations and lead exposure.

This faucet also appears to have an aerator/screen at the outlet. If the faucet is not replaced, the aerator/screen should be removed, inspected for particulate accumulations, scrubbed clean, and reinstalled. If particulates are found, the aerator/screen should be periodically checked and cleaned.

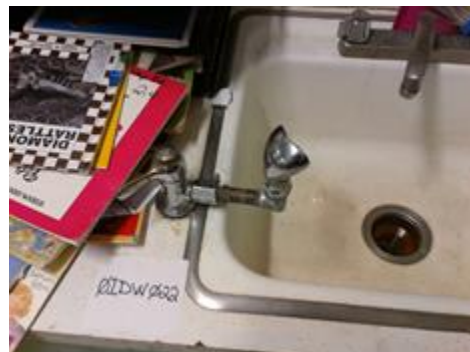
### **Outlet: Bubbler Fountain (01DW022)**

Location: Classroom 306, southwest wall

Results: P1=17 parts per billion, P2=6 parts per billion  
F01=4 parts per billion, F02=13 parts per billion

These results suggest lead may be from the bubbler and its connecting plumbing. This bubbler fixture is made of chrome-plated brass, with a brass operating valve, and a brass connector on the underside of the sink. Connecting plumbing in the cabinet under the sink should be checked for brass components and copper piping with lead solder. The increase in the fourth sample (F02) results may be a result of excessive water stagnation in this area of the building.

Replacement of this bubbler and its connecting plumbing with lead-free materials will significantly reduce lead exposure at this location, along with an overall flushing program. If replacement is not currently feasible, sample results indicate that flushing this tap for three minutes following periods of stagnation is likely to reduce lead concentrations and lead exposure.

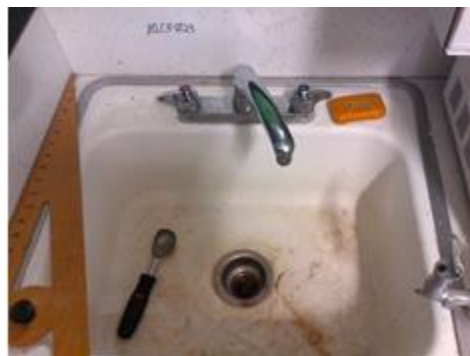
### **Outlet: Sink Faucet (01CF023)**

Location: Classroom 312, southeast wall

Results: P1=22 parts per billion, P2=14 parts per billion  
F01=9 parts per billion, F02=6 parts per billion

These results suggest the highest contribution of lead may be from the faucet and its connecting plumbing. This faucet appears to be manufactured by Chicago Specialty. This model faucet typically has a brass tube in its deck body, may contain some additional brass components, and has a brass spout. The spout's chrome finish is worn down to the brass. Connecting plumbing in the cabinet under the sink should be checked for brass connectors, copper piping with lead solder, and brass shut-off valves.

Replacement of this faucet and its connecting plumbing with lead-free materials will significantly reduce lead exposure at this location. If replacement is not currently feasible, sample results indicate that flushing this tap for three minutes following periods of stagnation is likely to reduce lead concentrations and lead exposure.

This faucet also appears to have an aerator/screen at the outlet. If the faucet is not replaced, the aerator/screen should be removed, inspected for particulate accumulations, scrubbed clean, and reinstalled. If particulates are found, the aerator/screen should be periodically checked and cleaned.

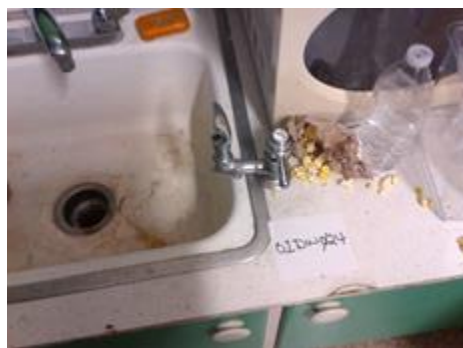
**Outlet: Bubbler Fountain (01DW024)**

Location: Classroom 312, southeast wall

Results: P1=36 parts per billion, P2=8 parts per billion  
F01=6 parts per billion, F02=4 parts per billion

These results suggest the highest contribution of lead may be from the bubbler and its connecting plumbing. This bubbler fixture is made of chrome-plated brass, with a brass operating valve, and a brass connector on the underside of the sink. Connecting plumbing in the cabinet under the sink should be checked for brass components and copper piping with lead solder.

Replacement of this bubbler tap and its connecting plumbing with lead-free materials will significantly reduce lead exposure at this location. If replacement is not currently feasible, sample results indicate that flushing this tap for three minutes following periods of stagnation is likely to reduce lead concentrations and lead exposure.

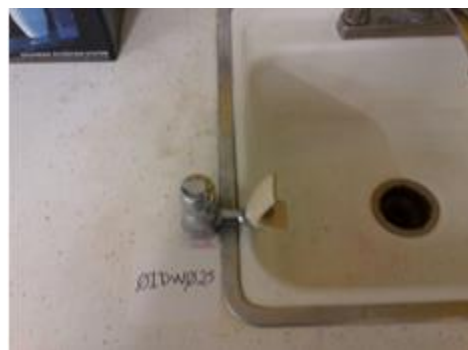
**Outlet: Bubbler Fountain (01DW025)**

Location: Classroom 307, southwest wall

Results: P1=191 parts per billion, P2=69 parts per billion  
F01=28 parts per billion, F02=6 parts per billion

These results suggest the highest contribution of lead may be from the bubbler and its connecting plumbing. This bubbler fixture is made of chrome-plated brass and has a brass connector on the underside of the sink. Connecting plumbing in the cabinet under the sink should be checked for brass connectors, copper piping with lead solder, and a brass shut-off valve.

Copper results for sample P1 at this location were also at levels above which the DEQ recommends school facilities take action. Copper results suggest these same brass components are contributing to this condition.

Replacement of this bubbler tap and its connecting plumbing with lead-free materials will significantly reduce lead and copper exposure at this location. If replacement is not currently feasible, sample results indicate that flushing this tap for three minutes following periods of stagnation is likely to reduce lead and copper concentrations and lead and copper exposure.

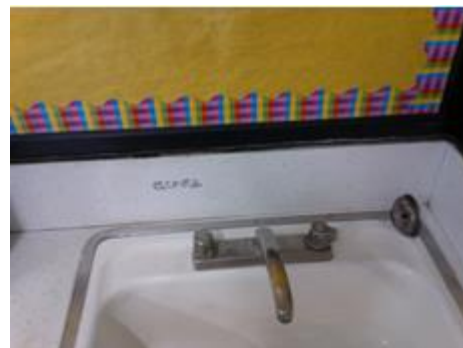
### Outlet: Sink Faucet (01CF026)

These results suggest the highest contribution of lead may be from the faucet and its connecting plumbing. This faucet appears to be manufactured by Central Brass. This model faucet typically has a brass tube in its deck body and, may contain some additional brass components, and has a brass spout. The spout's chrome finish is worn down to the brass. Connecting plumbing in the cabinet under the sink should be checked for brass connectors, copper piping with lead solder, and brass shut-off valves.

Replacement of this faucet and its connecting plumbing with lead-free materials will significantly reduce lead exposure at this location. If replacement is not currently feasible, sample results indicate that flushing this tap for three minutes following periods of stagnation is likely to reduce lead concentrations and lead exposure.

This faucet also appears to have an aerator/screen at the outlet. If the faucet is not replaced, the aerator/screen should be removed, inspected for particulate accumulations, scrubbed clean, and reinstalled. If particulates are found, the aerator/screen should be periodically checked and cleaned.

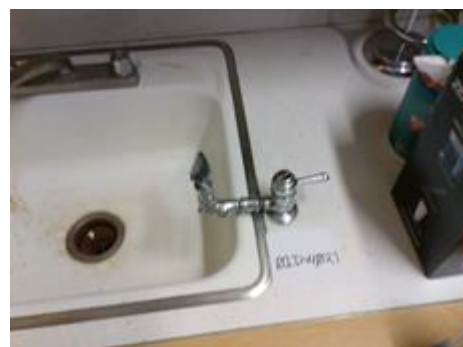
These results suggest lead may be from the bubbler and its connecting plumbing. This bubbler fixture is made of chrome-plated brass, with a brass operating valve, and a brass connector on the underside of the sink. Connecting plumbing in the cabinet under the sink should be checked for brass components and copper piping with lead solder. The increase in the third (F01) and fourth sample (F02) results may be a result of excessive water stagnation in this area of the building.

Replacement of this bubbler tap and its connecting plumbing with lead-free materials will significantly reduce lead exposure at this location and needs to be completed. In addition, an overall flushing program is required – even after this bubbler is replaced. If replacement is not currently feasible, **SHUT OFF THIS BUBBLER AND DO NOT USE THIS BUBBLER FOR DRINKING OR COOKING.**

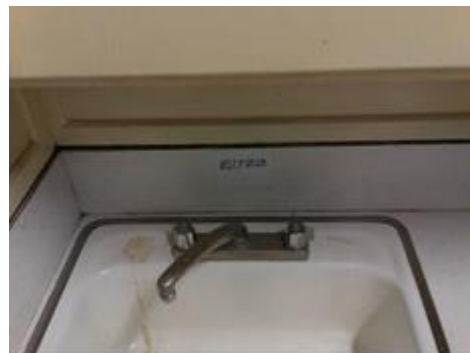
These results suggest the highest contribution of lead may be from the faucet and its connecting plumbing. This faucet appears to be manufactured by Central Brass. This model faucet typically has a brass tube in its deck body, may contain some additional brass components, and has a brass spout. The spout's chrome finish is worn down to the brass. Connecting plumbing in the cabinet under the sink should be checked for brass connectors, copper piping with lead solder, and brass shut-off valves.

Replacement of this faucet and its connecting plumbing with lead-free materials will significantly reduce lead exposure at this location and needs to be completed. In addition, an overall flushing program is required – even after this faucet is replaced. If a replacement is not currently feasible, **DO NOT USE THIS FAUCET FOR DRINKING OR COOKING.**

This faucet also appears to have an aerator/screen at the outlet. If the faucet is not replaced, the aerator/screen should be removed, inspected for particulate accumulations, scrubbed clean, and reinstalled. If particulates are found, the aerator/screen should be periodically checked and cleaned.

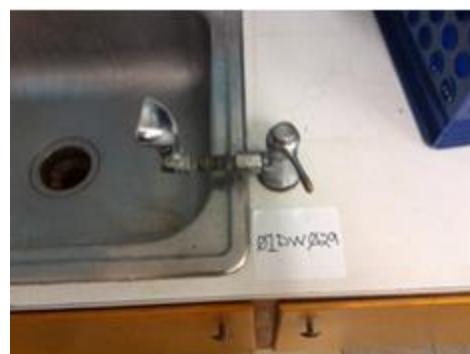
These results suggest the highest contribution of lead may be from the bubbler and its connecting plumbing. This bubbler fixture is made of chrome-plated brass, with a brass operating valve, and a brass connector on the underside of the sink. The bubbler also has been modified with added copper couplings below the spout. Connecting plumbing in the cabinet under the sink should be checked for brass components and copper piping with lead solder.

Replacement of this bubbler tap and its connecting plumbing with lead-free materials will significantly reduce lead exposure at this location. If replacement is not currently feasible, sample results indicate that flushing this tap for three minutes.

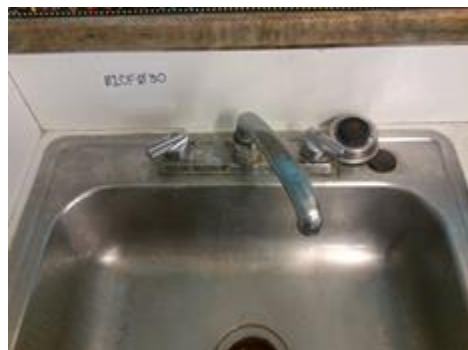
These results suggest the highest contribution of lead may be from the faucet and its connecting plumbing. This faucet appears to be manufactured by Central Brass. This model faucet typically has a brass tube in its deck body, may contain some additional brass components, and has a brass spout. The spout's chrome finish is worn down to the brass. Connecting plumbing in the cabinet under the sink should be checked for brass connectors, copper piping with lead solder, and brass shut-off valves.

Replacement of this faucet and its connecting plumbing with lead-free materials will significantly reduce lead exposure at this location. If replacement is not currently feasible, sample results indicate that flushing this tap for three minutes following periods of stagnation is likely to reduce lead concentrations and lead exposure.

This faucet also appears to have an aerator/screen at the outlet. If the faucet is not replaced, the aerator/screen should be removed, inspected for particulate accumulations, scrubbed clean, and reinstalled. If particulates are found, the aerator/screen should be periodically checked and cleaned.

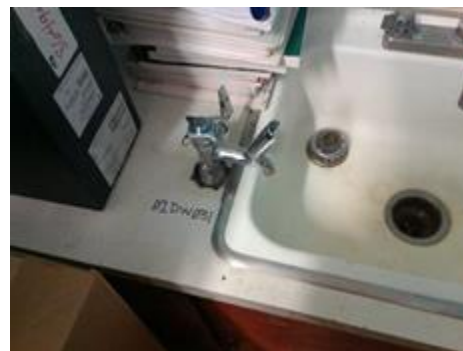
These results suggest the highest contribution of lead may be from the bubbler and its connecting plumbing. This bubbler fixture is made of chrome-plated brass and has a brass connector on the underside of the sink. Connecting plumbing in the cabinet under the sink should be checked for brass components and copper piping with lead solder.

Replacement of this bubbler tap and its connecting plumbing with lead-free materials will significantly reduce lead exposure at this location. If replacement is not currently feasible, sample results indicate that flushing this tap for three minutes following periods of stagnation is likely to reduce lead concentrations and lead exposure.

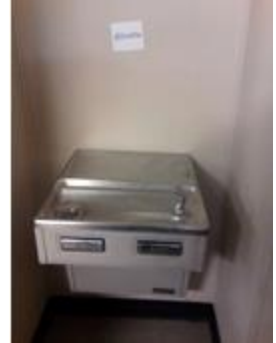
Copper results for sample P1 at this location were also at levels above which the DEQ recommends school facilities take action. Copper results suggest these same brass components are contributing to this condition.

Replacement of the entire unit is recommended and will significantly reduce lead and copper exposure at this location. If replacement is not currently feasible, sample results indicate that flushing this tap for three minutes following periods of stagnation is likely to reduce lead and copper concentrations and lead and copper exposure.
